Scienxt Journal of Concrete Technology & Materials  
Year-2024 || Volume-1 || Issue-1 || pp. 67-76

## *Effect of reinforcement corrosion on flexural behaviour of concrete beams*

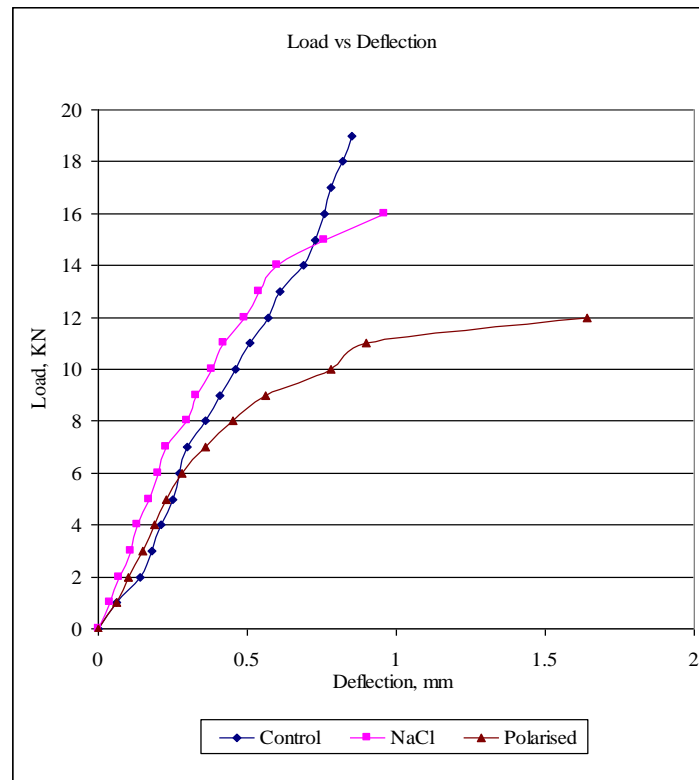
**Figure. 2: Load Vs deflection**

to electrochemically accelerate the corrosion of reinforcement. In system 3, the specimen was initially cured in potable water for 7 days and subjected for accelerated corrosion for 21 days. The specimens were tested in flexural testing machine to find out deflection for a gradual increase in load. Table.1 shows the flexural load, deflection and crack width of the test specimens. Figure.2 shows the Load-Deflection behaviour for the test specimens.

From the table.1, it is observed that the deflection in system 1 is only 0.81mm and therefore it satisfies the serviceability requirements. The deflection of the system-2 specimen is 0.95mm.

In system-2, the deflection is 1.17 times more than that of system-1 specimen. However, the value is still within the permissible limit of 1.314mm. The deflection observed in system-3 is, 1.64mm. In system-3 the deflection observed is twice the deflection of the system-1. System-

3 fails the serviceability requirement. The excessive deflection in system-3 is solely due to reinforcement corrosion brought about by electrochemical acceleration.

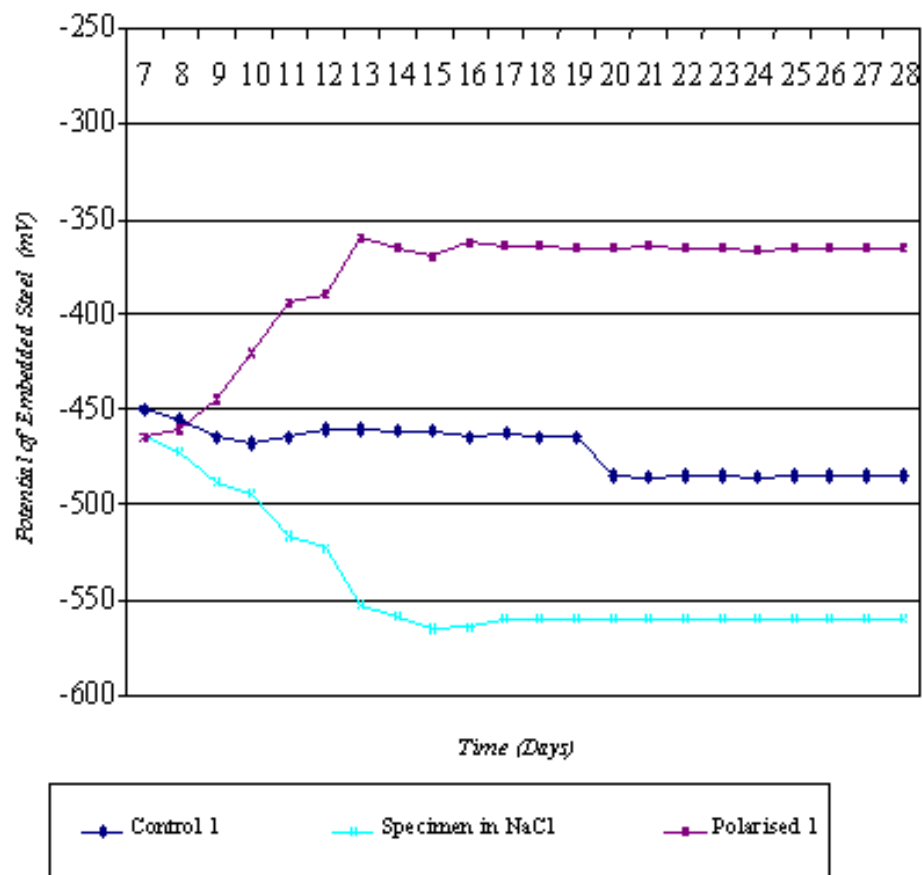
Fig. 3 shows the potential trend of embedded steel in concrete. From the figure, it is observed that the potential of rebars in system-1 moves slightly in the negative direction and then remains constant at -485mV Vs SCE.

In system-2, the potential gradually increases in the negative direction and at the end of 7 days gets stabilized at -560mV Vs SCE. The potential shift is about 75mV and this shift is due to chloride concentration gradient. The chloride ions from NaCl solution move through the pores and initiates corrosion on steel reinforcement and as a result potential moves in the more negative direction.

In system-3, the embedded reinforcement has been anodically polarized and as a result the potential is shifted in positive direction. The potential gradually increases in the positive direction and at the end of 17 days gets stabilized at -365mV Vs SCE. The potential shift in the positive direction is about 120mV.

Figure. 3: Potential trend of embedded steel

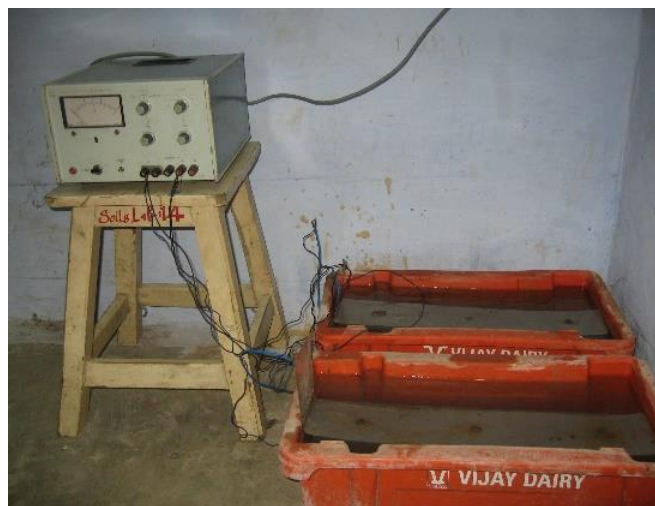
*Figure. 5: Accelerated corrosion*

In this study, three systems were evaluated. In system 1 the specimens were made as control and cured in potable water for 28 days. In system 2 specimens were cured in potable water for 7 days and then cured in 3.5% sodium chloride solution for 21 days. This is to chemically accelerate the corrosion of reinforcement. In system 3 the embedded steel reinforcement was subjected to accelerated corrosion by external applied anodic current of 500mA. The idea was
